FACILITY COMPLIANCE INSPECTION REPORT

Division of Waste Management Solid Waste Section

Carteret County/CRSWMA Transfer Facility
800 Hibbs Road
Newport, NC

1604T-20120702INSP

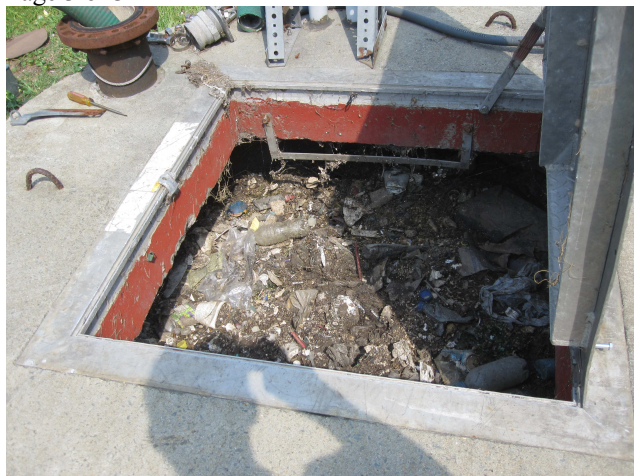
- 19) Leachate is collected on-site in an above ground storage tank and is pumped down and hauled for treatment as needed.
- 20) *The underground leachate pump station needs to be cleaned of sediment and debris to ensure proper management of all leachate generated at this facility.

Leachate pump station needing cleaning

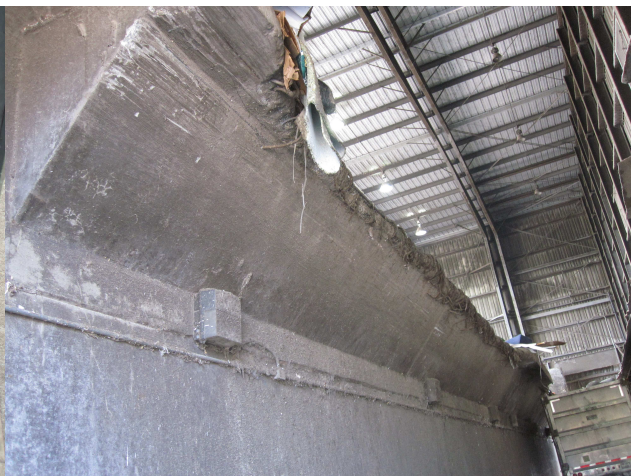
Exposed re-bar at edge of loading bay

- 17) Recyclable metals and unacceptable waste streams are removed from the facility daily.
- 18) Areas of excessive wear were noted in various areas on the tipping floor; exposed re-bar was noted at the loading bay edge of the tipping floor. *Plans for maintenance/repair of the worn and eroded areas of the tipping floor should be initiated as soon as possible.
